Monitoring Data Record

Project Title: R-2552B Clayton Bypass COE Action ID: 200220745
 Stream Name: Site 5 DWQ Number: 041760
 City, County and other Location Information: US 70 Clayton Bypass from I-40 to US 70
Station 82+60 to 85+50 -L-
 Date Construction Completed: 4/21/06 Monitoring Year: (4) of 5
 Ecoregion: _____ 8 digit HUC unit 03020201
 USGS Quad Name and Coordinates: _____

R-2552B Clayton Bypass

Year 4 Summer – July 2010

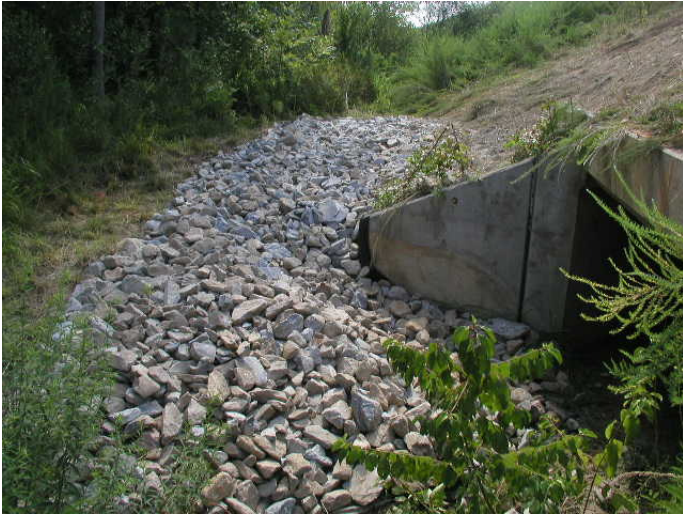
The stream relocation is stabilized for the Year 4 Summer evaluation. The minor bank scouring on the right bank at Station 11+10 - S- noted during the last evaluation has re-vegetated and is stabilized. The bank erosion at the inlet end of the box culvert around the right wing wall has been repaired (see photo). NCDOT will continue to monitor channel stability at this stream relocation.

Repaired area at inlet side of box culvert
at Sta. 11+20 - S -
